Flight Motor Set 360L006 (STS-34) Final Report

Volume I - System Overview

February 1990

Thiokol CORPORATION
SPACE OPERATIONS

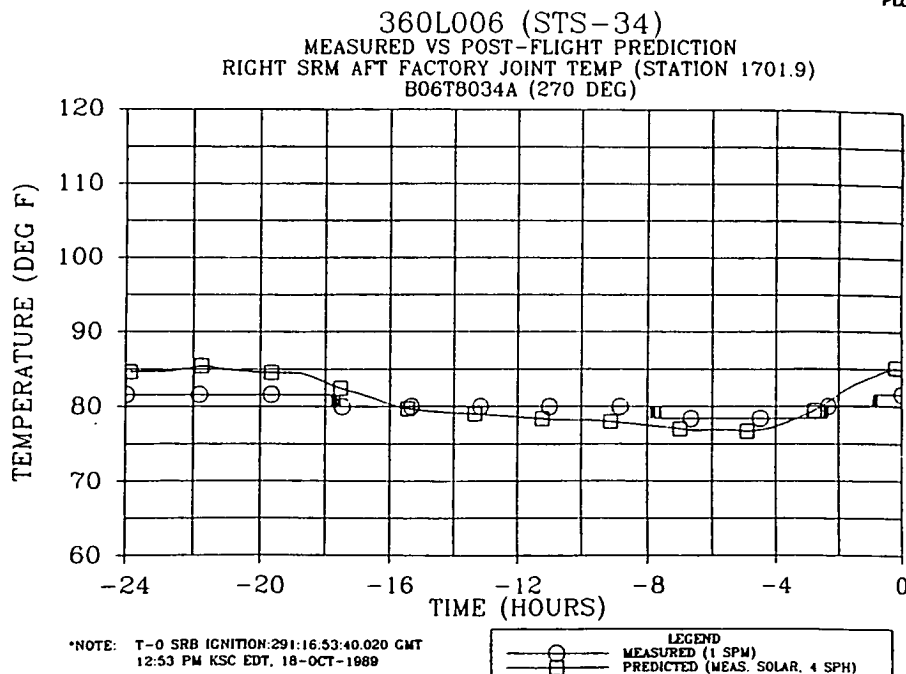
Figure 4-122. RH SRM Aft Factory Joint Temperature at Station 1701.9, B06T8034A (270-Deg) – Measured Versus Postflight Prediction
